# EXHIBIT D

**Forensic Report**  
**May 26, 2022**

**File:**           **McCoy vs. GM – 2018 GMC Sierra HD**

**Subject:**       **Vehicle Safety Performance**

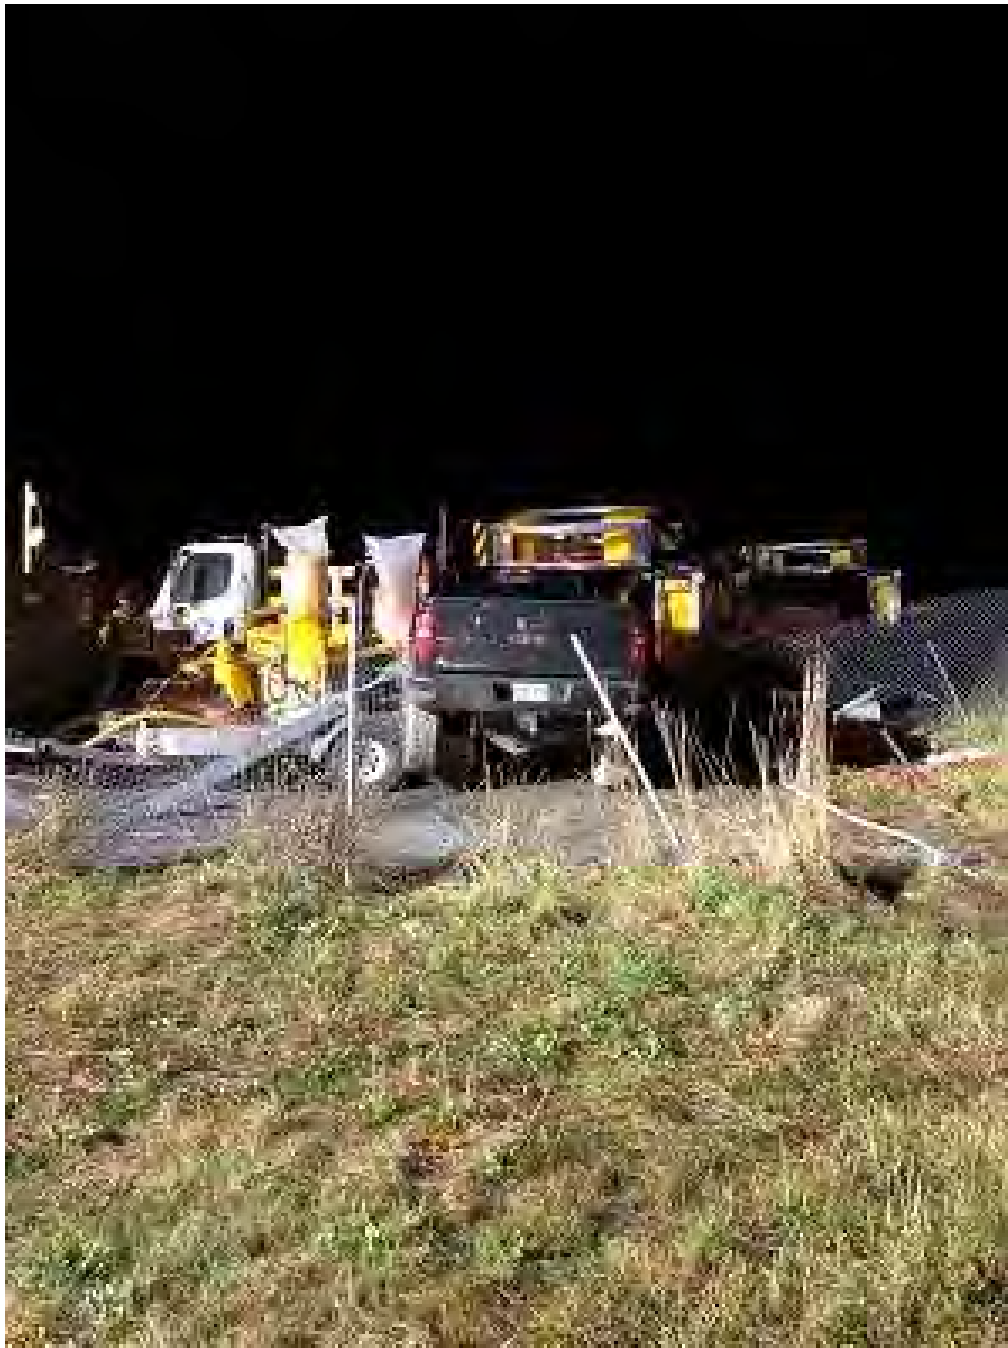
2018 GMC Sierra HD – Scene Photo

The scene photo below shows the truck having gone through the fence and sitting atop the flatbed trailer up against the construction truck.

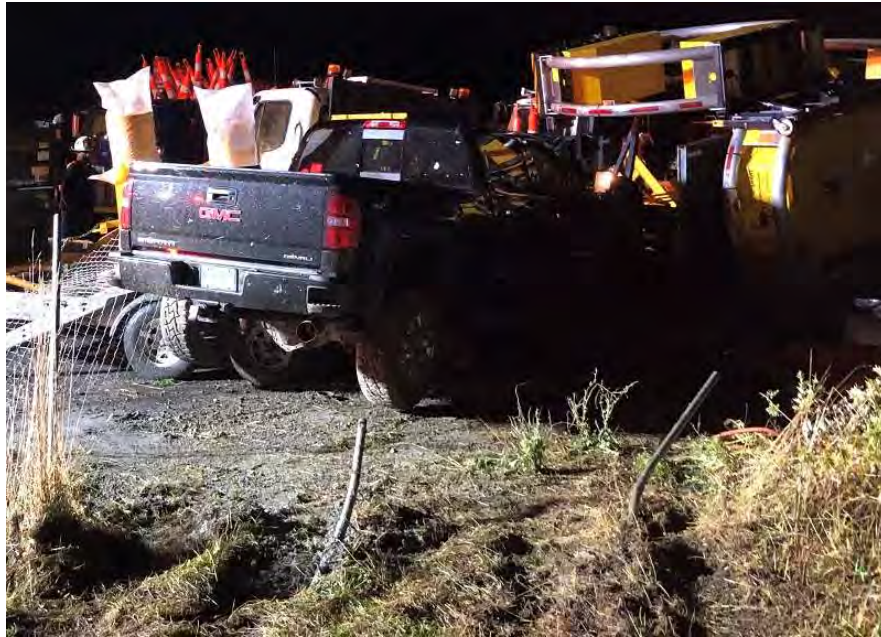
2018 GMC Sierra HD – Scene Photo

The following 2 scene photos shows the vehicle up against the axle of the construction truck.

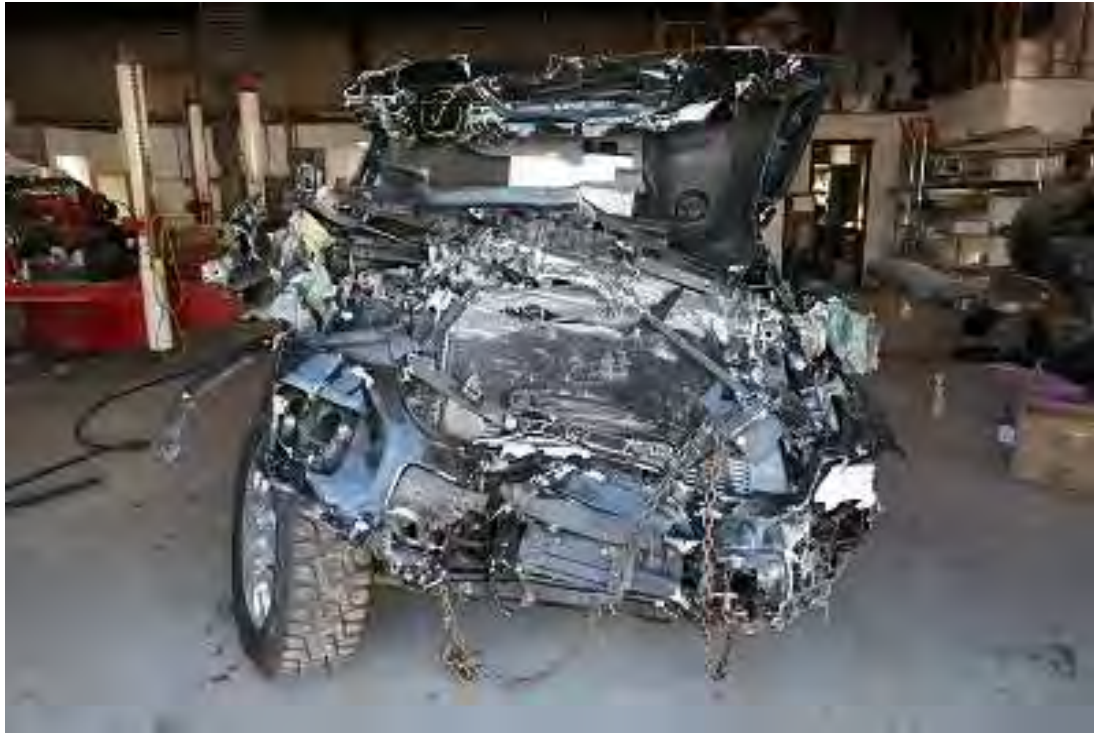
2018 GMC Sierra HD – Inspection Photo

This photo is of the post-accident subject 2018 GMC Sierra HD vehicle. Clearly there is a moderate to severe frontal impact to the front of the vehicle, which would warrant the deployment of the driver frontal impact airbag. The failure to deploy the airbag resulted in a vehicle that was defective, unsafe and unreasonably dangerous and led directly to the injuries suffered by Mr. McCoy.

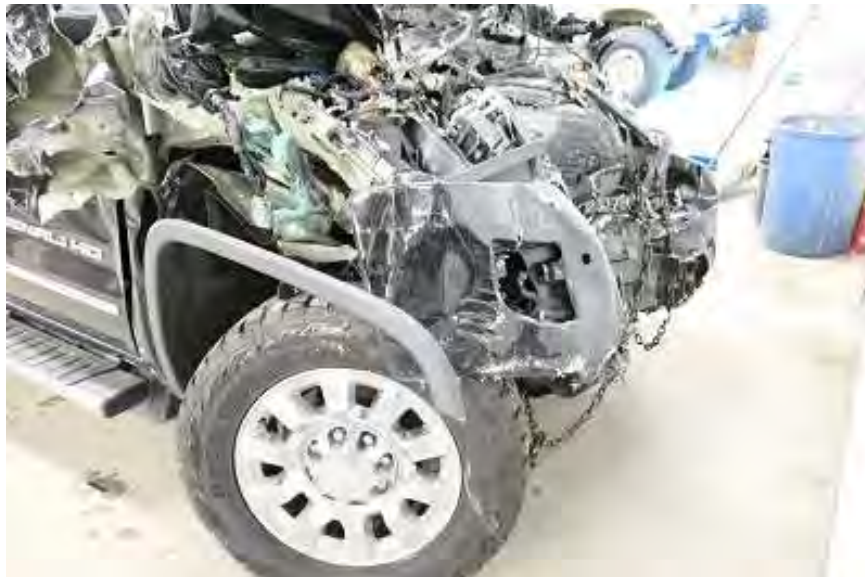
2018 GMC Sierra HD – Inspection Photo

In our case, the subject collision still had a significant impact into the bumper and rails from the engagement with the construction truck axle, but clearly there was an underride component since the top of the radiator is clearly pushed further rearward than the lower radiator support and bumper structures.

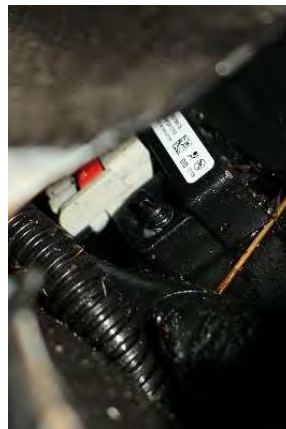
#### 2018 GMC Sierra HD – Inspection Photo – EFS Rotated Upward

During my inspection, I noted that the EFS sensors and the entire lower radiator support were rotated rearward and upward at some point in the collision sequence.

This rotation, if it occurred early in the construction truck crash or during the trailer undercarriage impact, this would have taken the EFS sensor out of the primary frontal impact direction (they have a single axis accelerometer inside that needs to be looking forward) and with them pointed upward in the vertical direction they would no longer be seeing the fore/aft crash severity and would fail to determine that airbag deployment was necessary.
